6/27 NW  
AL N  
JOINT FEDERAL/STATE APPLICATION FOR THE ALTERATION OF ANY FLOODPLAIN  
WATERWAY, TIDAL OR NONTIDAL WETLAND IN MARYLAND

The project is a 40 unit family housing building in Allegany County, Maryland

- A. County: Allegany B. City: Frostburg C. Name of waterway or closest waterway Winebrenner Run  
D. State stream use class designation: III  
E. Site Address or Location: 11900 Old Legislative Road, SW, Frostburg, MD  
F. Directions from nearest intersection of two state roads: Take Exit 33 on US 68 (Frostburg) and travel south on Old Legislative Road (County Road 736) approximately 0.5 miles. The site is located on the left just south of All Safe Self Storage.

**Preliminary Jurisdictional Determination Report  
Allegany Junction  
Approximately 8 Acre Property  
11900 Old Legislative Road, SW  
Frostburg, MD**

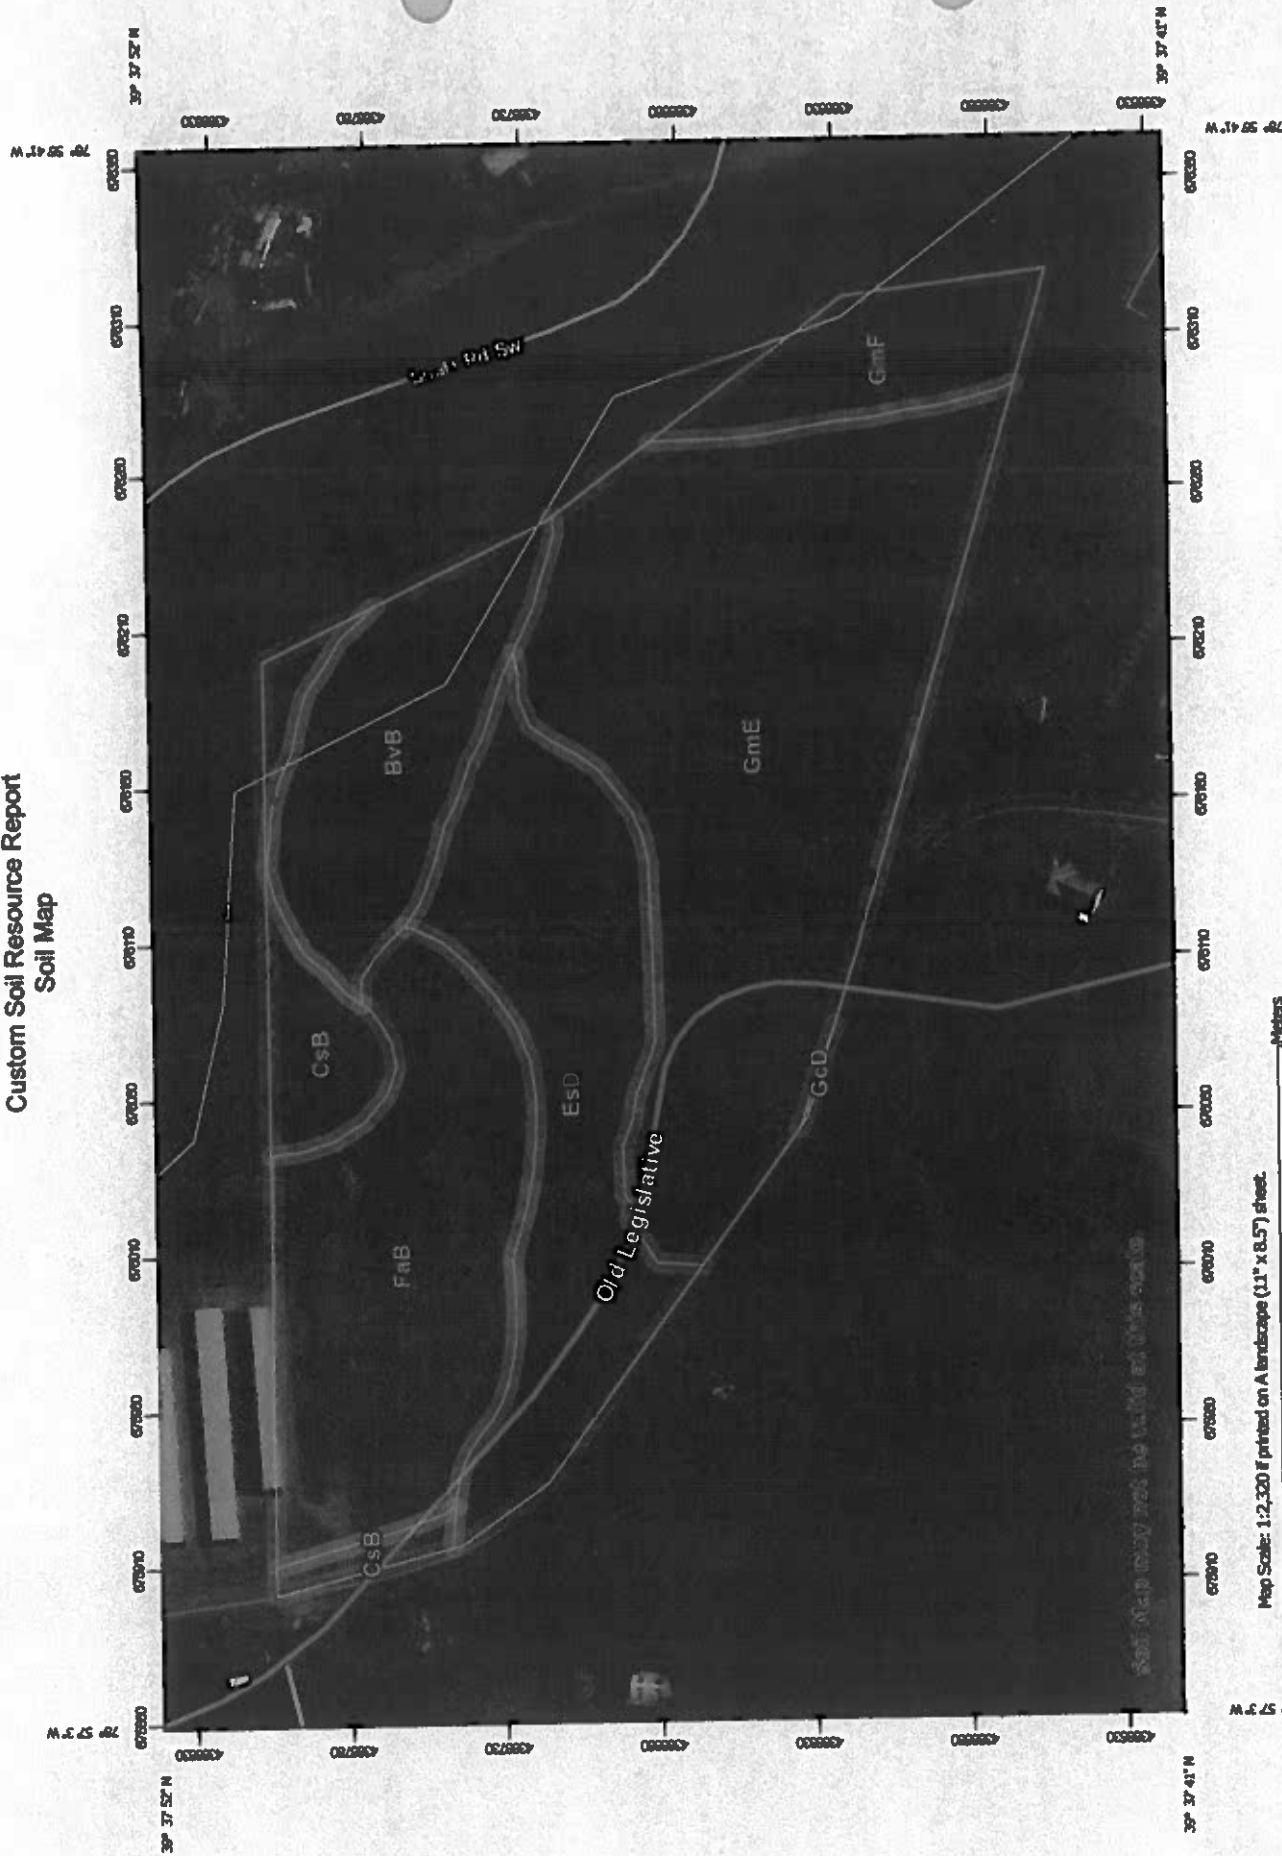
# Custom Soil Resource Report Soil Map

Map Scale: 1:2,320 if printed on A landscape (11" x 8.5") sheet.

The United States Department of Agriculture, Web Soil Survey for the area shows 7 soils occurring within the delineation area. The soils identified in the soil report are all non-hydric meaning they are not known to be commonly saturated, flooded, or inundated, thus supporting wetland conditions. Please refer to Appendix C for a soil report of the property.
